Characteristics of leader/return stroke sequence along one of multiple branches of upward lightning discharges

ABSTRACT: We performed a study on the return strokes which occurred along one of the branches of upward lightning at the instant when at least one of the remaining branches is still carrying significant currents. It was found that the rise time of the return stroke current is not affected either by the current along the branch or the height of branch joint point, which is contrary to our expectation.

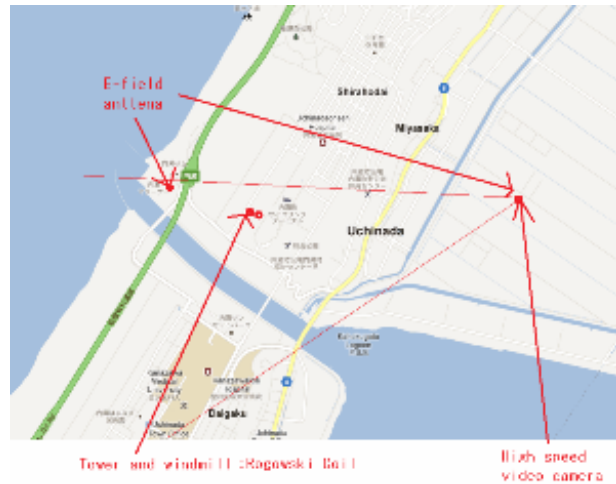
Fig.2 Arrangement of equipment

The high speed video camera we used is MEMRECAM GX-8. Our observation target is the lightning to a windmill and its lightning protection tower and a bridge girder which locate at Uchinada town in the northern coast area of Japan as shown in Figure 1. The high speed was set up about 1.4 km away from the windmill as shown in Figure 2 with its view shown in Figure 3. The electric currents of the lightning to the windmill and the tower were measured using Rogowski coils installed at the bases of the windmill and the

tower. The Rogowski coils have a bandwidth from 1 Hz to 100 kHz and their outputs were sampled at either 500 kS/sec or 200 kS/sec with a amplitude resolution of 16 bit. Lightning-caused electric changes were recorded using slow and fast antenna. The time constants of the slow and fast antenna are 2.2 ms, 47 μ s, respectively and their output were sampled at 100 kS/sec with a amplitude resolution of 16 bit.

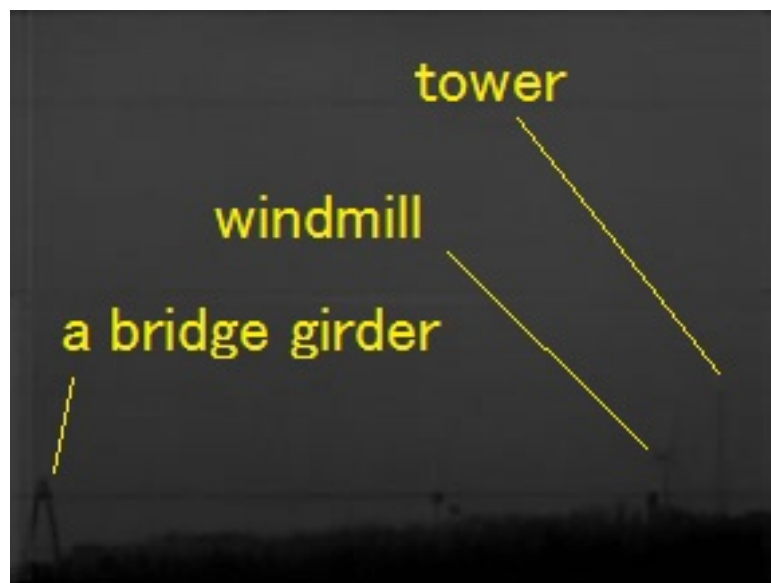
Fig.3 View of high speed video camera
